**MT-RAP-2008-00100/mso**

**Summary of coating surveys  
on the four air command frigates  
(Zeven Provinciën class)**

Date	March 26, 2008
Author	R. van der Kaaden, B.Sc. (TNO Quality Services B.V.)
Client	Ministry of Defence DMO / DWS / RZS / PLTFT Corrosion Prevention Attn. of Mr. H. Bakuwel, B.Sc. MPC 58 A P.O. Box 90822 2509 LV The Hague
Classification report	Unclassified
Classified by	H. Bakuwel, B.Sc.
Classification date	March 12, 2008
Title	Unclassified
Managementuittreksel	Unclassified
Abstract	Unclassified
Report text	Unclassified
Appendices	Unclassified
Copy no	18
No. of copies	22
Number of pages	40
Number of appendices	1

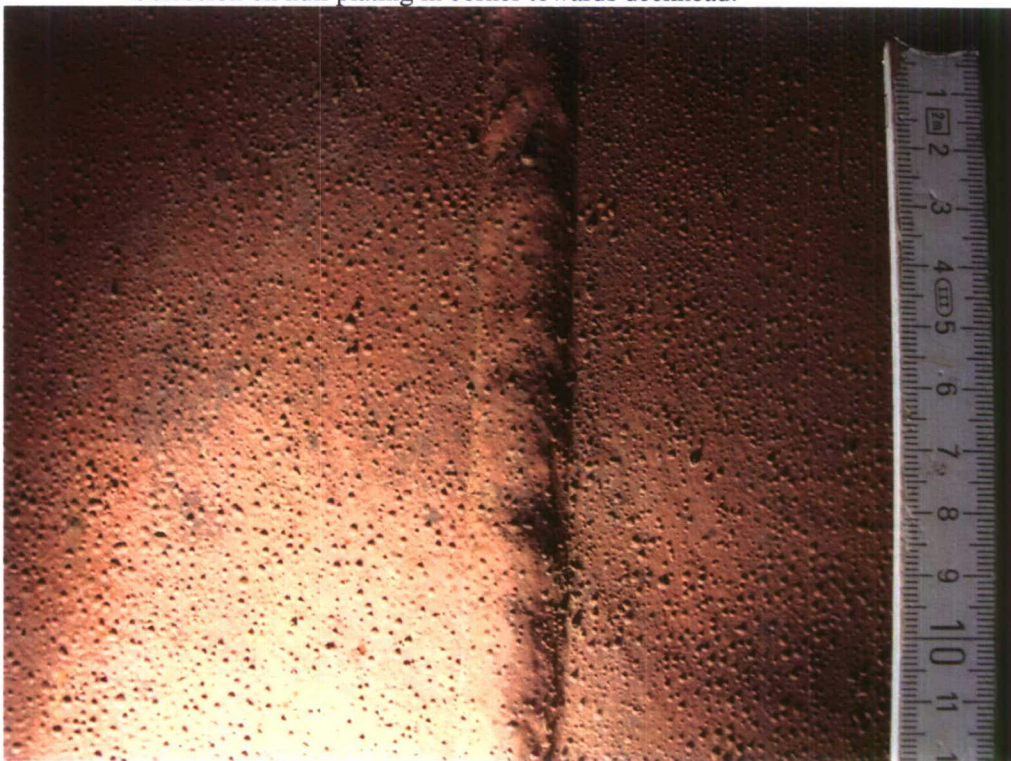
- In tanks on all LCF's, typical damage patterns have been observed where blistering was more intense in areas with a low coating thickness (< 50-70  $\mu\text{m}$ ) and less intense in surrounding areas with a higher coating thickness (> 80-100  $\mu\text{m}$ ).

Photo 12: Hr.Ms. "Tromp" (LCF 2). Fuel storage tank 1 (03.08.2006).  
Dense blistering on tank bottom.

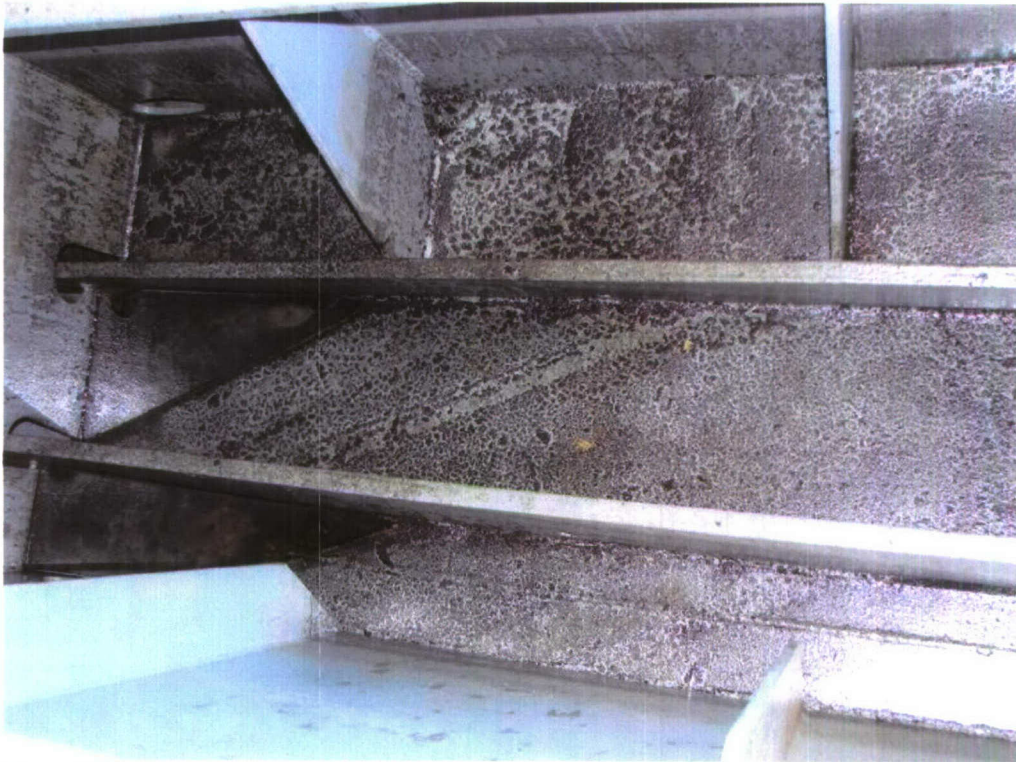
Photo 17: Hr.Ms. "Zeven Provinciën" (LCF 1). Dieselgeneratorroom (25.06.2007).  
Dirty, oily bottom area with staining due to corrosion of metal particles on top of coating.

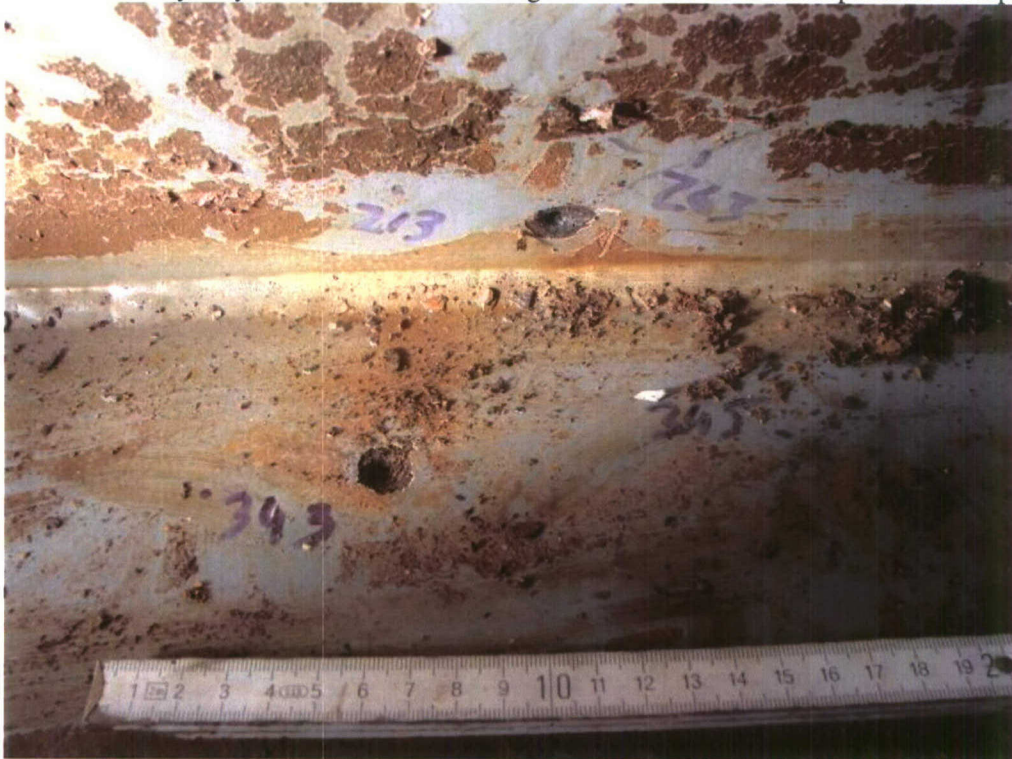
- On all LCF's, pitting corrosion has been observed in bilges, especially in pump rooms 2 and 3 (photo 18). The depths of the pits varied from approx. 1 mm up to 6-7 mm.
- A black substance was present in the pits.
- Additional investigations have been carried out into the cause of pitting in pump room 2 on LCF 1. Sulphur reducing bacteria have been identified, as well as fungi. Sulphur reducing bacteria can result in pitting corrosion. Access to the steel was possible due to the mechanical damages.
- As can be expected in bilges, the coating system frequently shows corrosion as a result of mechanical damages. Additionally metallic particles are present on the coating surfaces, which develop corrosion.
- Cracks due to high coating thicknesses sometimes reaching the steel resulted in penetrating corrosion.

Photo 18: Hr.Ms. "De Ruyter" (LCF 3). Pump room 3 (14.11.2006).  
Pitting corrosion on hull and vertical side in compartment 3 from fore.
